CONFIDENTIAL SERVICE PHILCO

RADIO No. 26

DATE: 9-16-41

COMPLETE INFORMATION ON THE 1942 RECORD CHANGERS

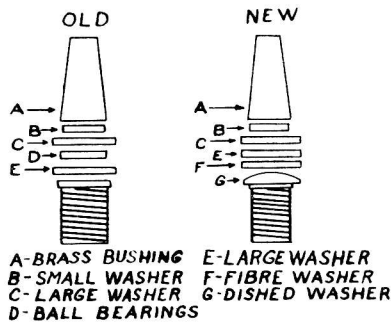
FIGURE 1

A. The rumble in the Models 42-1010 and 1016 can be easily corrected by replacing the turntable bearing. Remove the turntable and the spindle and then take out the brass cone and the ball bearings and washers. Rebuild the bearing, using the old washers and the new flat fiber washer and the concave steel washer. (See Figure 1). Add "Stay-Put Grease" or "Lubriplate" between the washers to eliminate friction. When replacing the spindle assembly, the spindle must be more than $\frac{1}{2}$ turn loose while lining it up with the record support shelf.
