# PHILCO SERVICE SUPERVISOR

JULY, 1954

## TELEVISION SERVICE "HINTS AND KINKS"

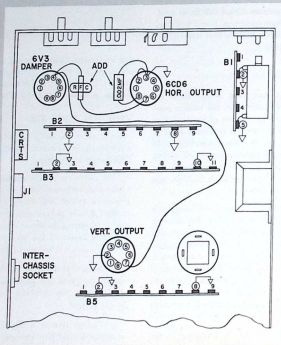
FIGURE 3

3. The most serious cause of hum is due to the pick-up by components or wiring of the first audio stage.

The hum is picked up from the B-lead which passes by the 6T8 tube. This lead is a white lead connected to pin #11, of the interchassis cable. This lead should be redressed as indicated in figure 3.
