Philco Model 46-1209 AM/SW Console Radio
Donald R. Sentz
July 2018, Rev. F December 2020

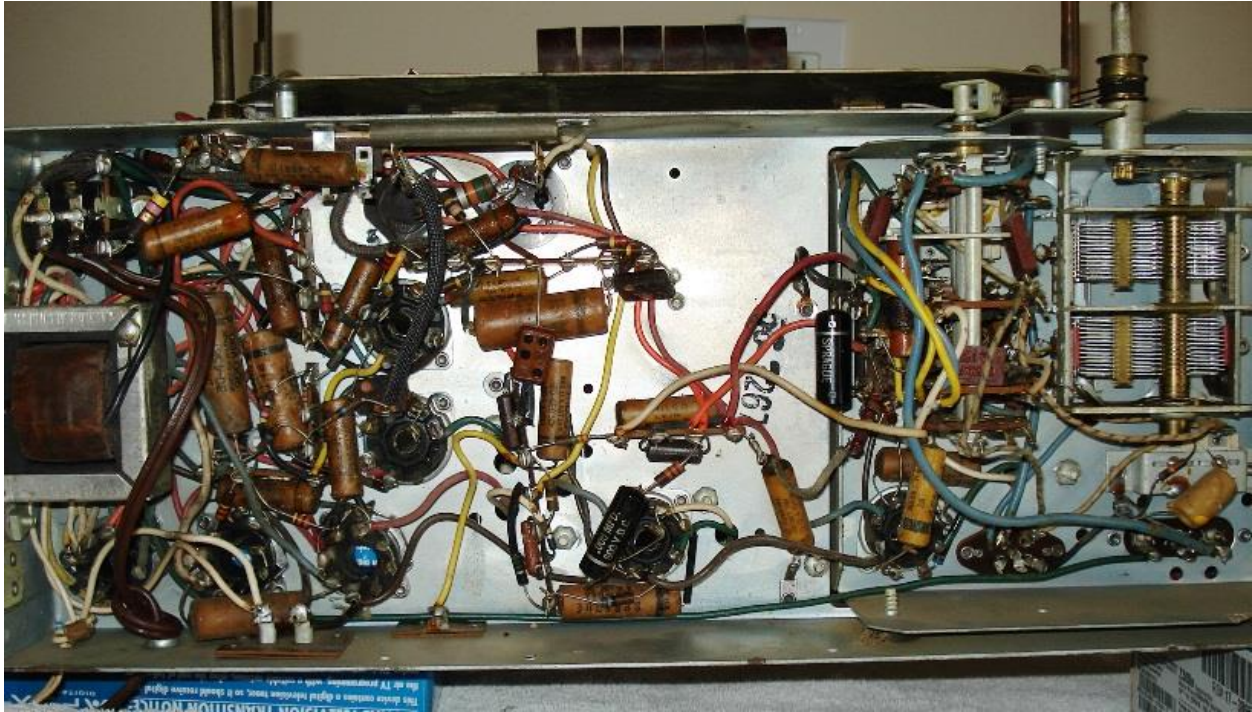
Chassis Underside Prior to Electrical Restoration

June-July 2018- During cleaning and inspection of the chassis, I saw evidence of prior repairs. I replaced all of the tubular paper capacitors and the three electrolytics. I left the old electrolytic cans in place. The old C49 can is electrically isolated from the chassis, so I used the center post of C49 as a convenient tie point. Note that C49 should not be touched when the set is ON.

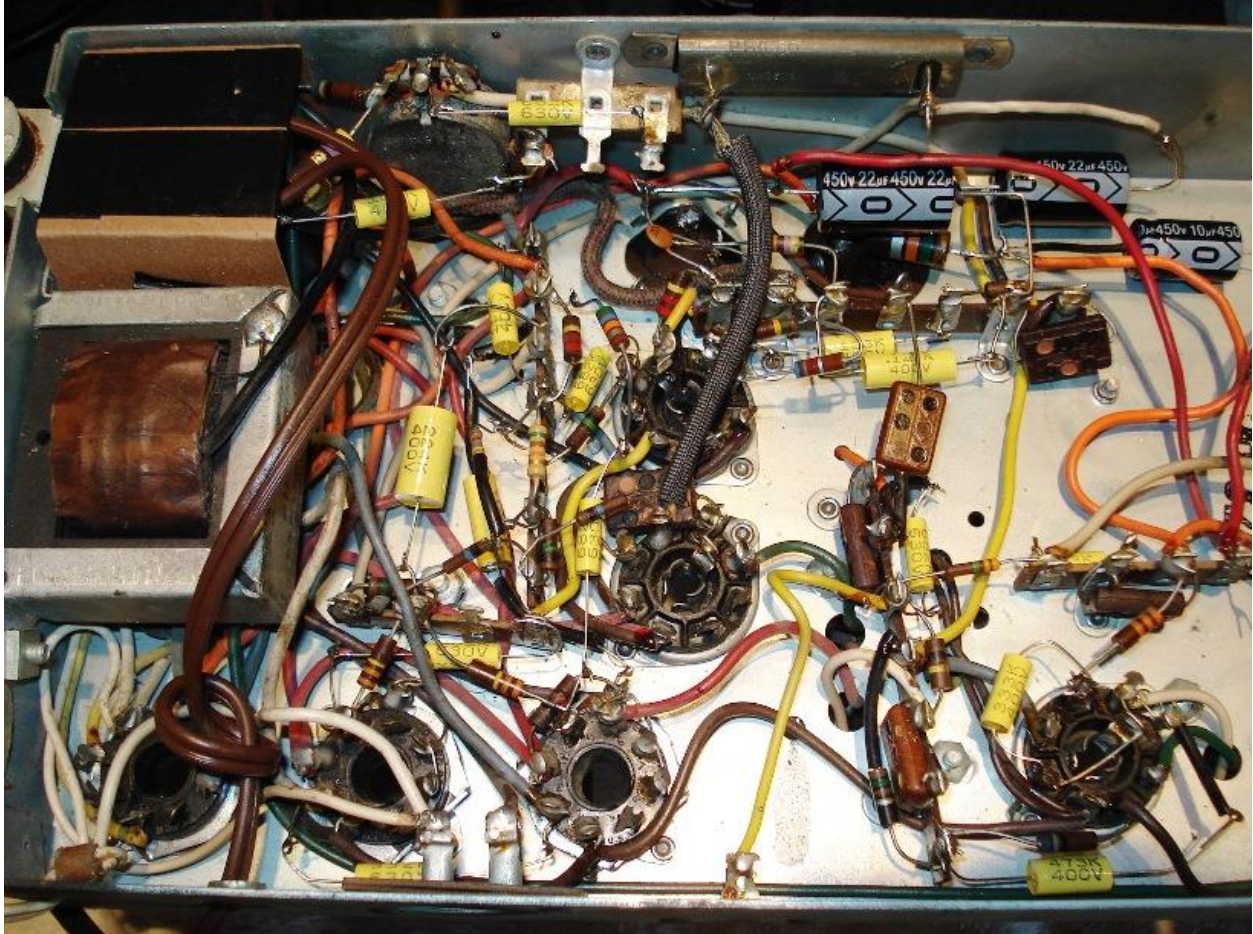
C53A and C53B measured way out-of-spec. I left C53 in place and fastened a small wooden platform to it. I re-wired that area for the new .01uF capacitors replacing C53A and C53B. I fashioned an insulating cover over the re-wired area for safety.

Left Side of Chassis After Installing New Parts

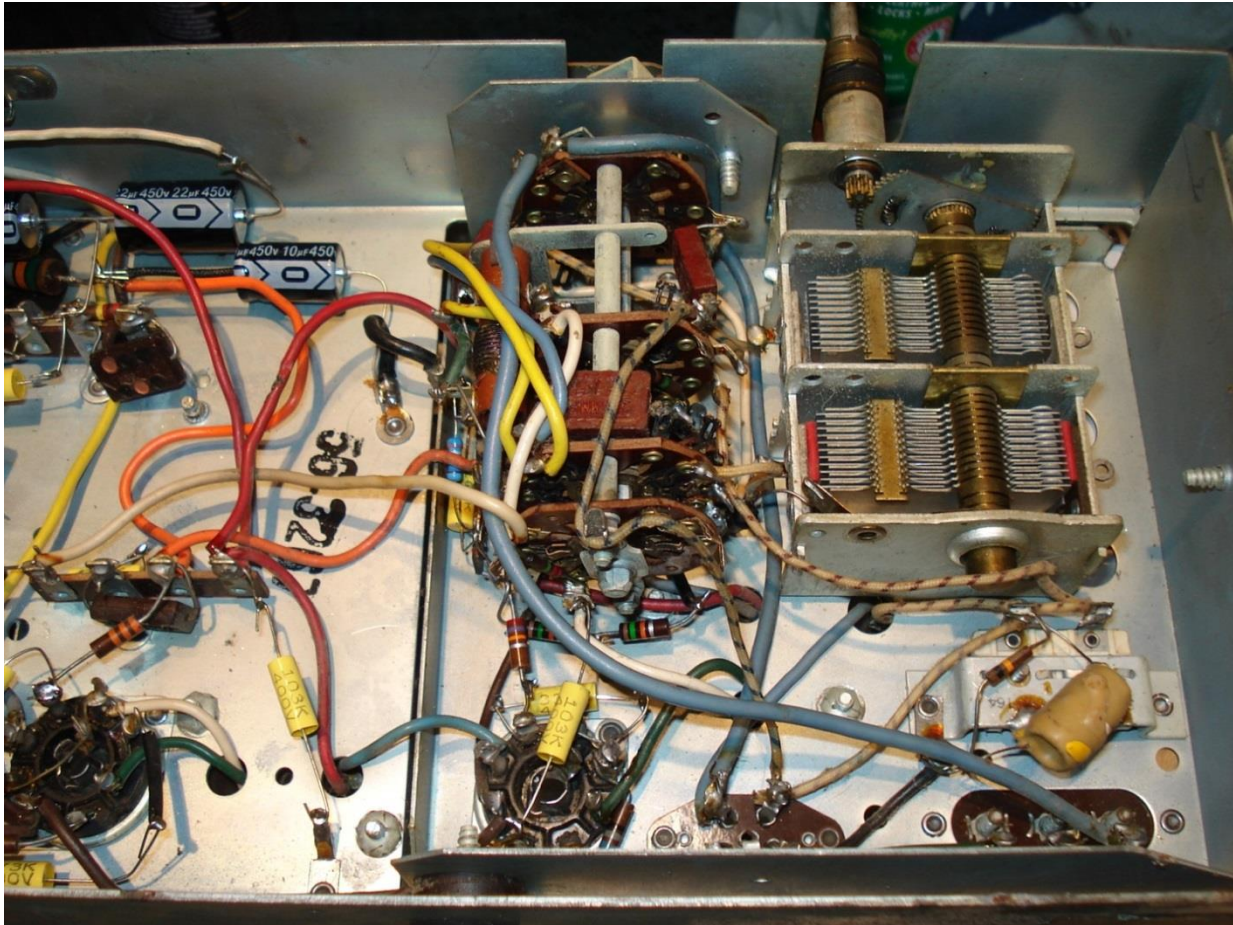
Right Side of Chassis After Installing New Parts

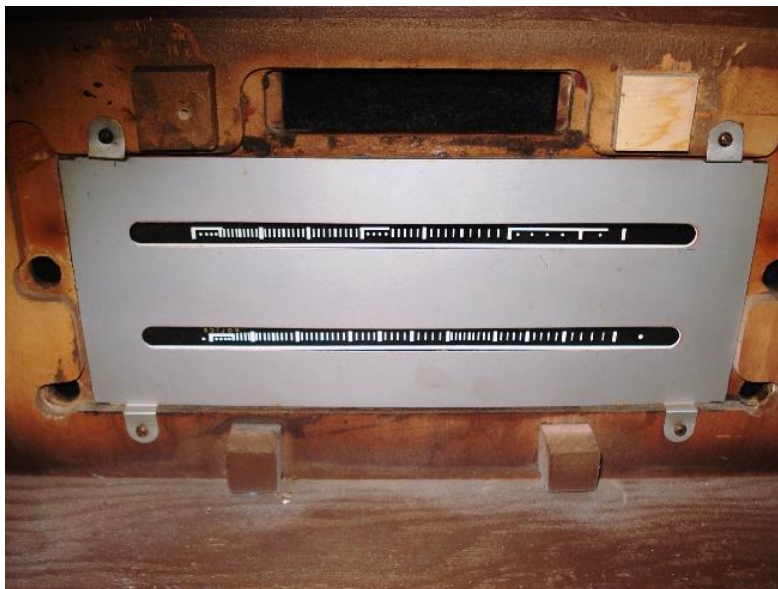
The cabinet was missing a 1"x1"x 3/8" wood block that is used to support the left side of the pushbutton assembly (as viewed from front of set). I fashioned a replacement and installed it using Elmer's white glue.

New Support Block at Upper Right Prior to Drilling Hole

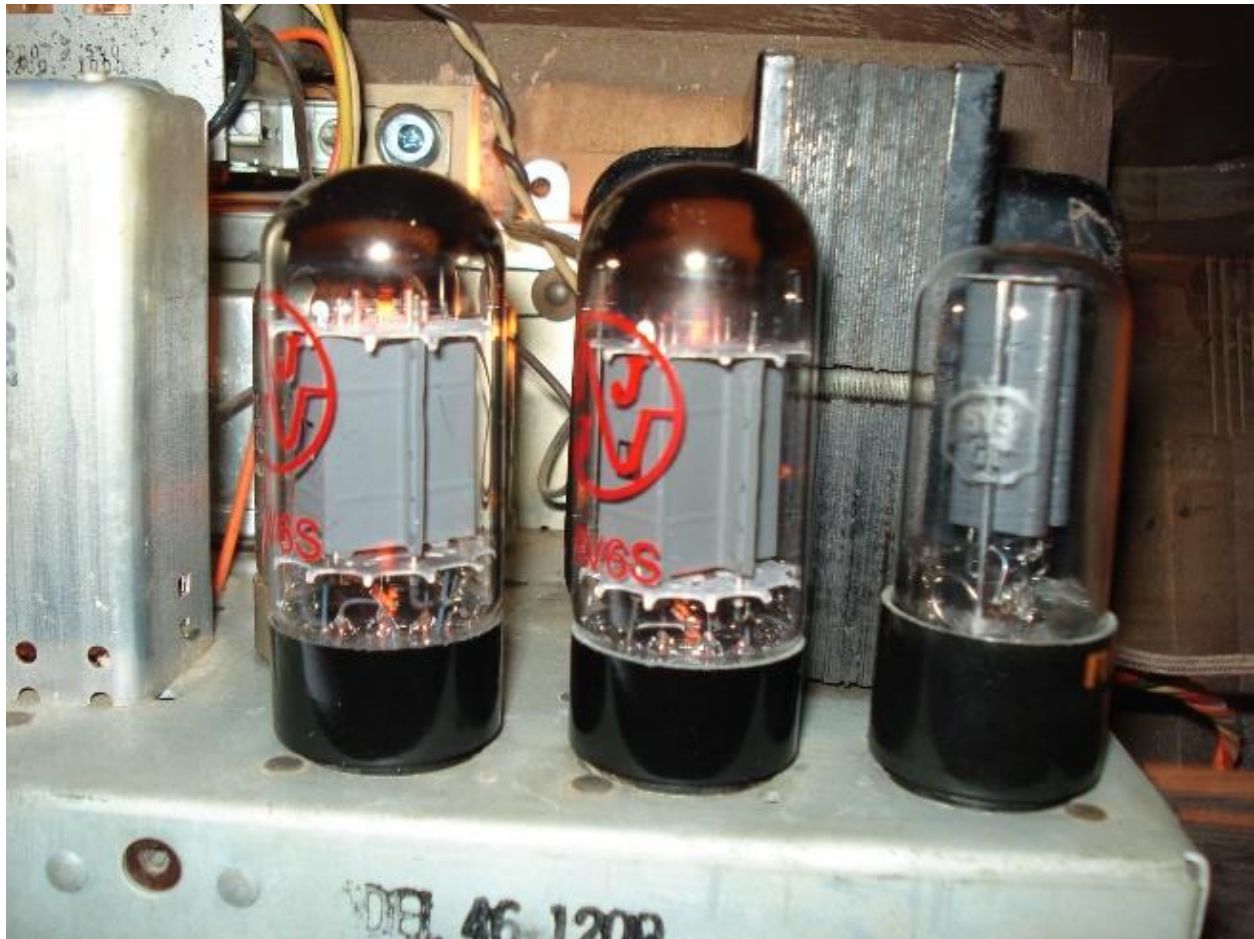
glasses, and used a hand-held mirror to observe both 6V6-S tubes in operation from different angles. After my eyes adjusted to the dark I observed faint, cobalt-blue glow as localized streaks between the glass envelope and the plate, in BOTH tubes. The 6V6-S closest to the 5Y3 also exhibited a dim blue haze localized to just above the surface of the lower support wafer. The other 6V6-S may have this haze also, but it was much more faint and I am not 100% sure of it.

Two JJ Electronic 6V6-S Installed November 2, 2019. The one in the middle has some dim blue glow. See also notes added to Appendix B, Sub-Section 3.

02Nov2019- The two JJ 6V6-S tubes work fine, but one has a very dim blue glow that seems to be emanating from the top of the lower support wafer. When I look through the cutouts in the plate I do not see any blue glow in the space above that wafer and inside the plate cylinder. There are two other very small blue glows that appear to be on the glass and in the vicinity of those cutouts. These "glass glows" mostly disappear after the set has been on for a while. The other JJ tube has no visible blue glows.
