## Philco Radio & Television Corp.

**Model:** 89

## Correcting Intermittent Operation

MODEL 89,19  
Schematic  
Alignment  
Changes

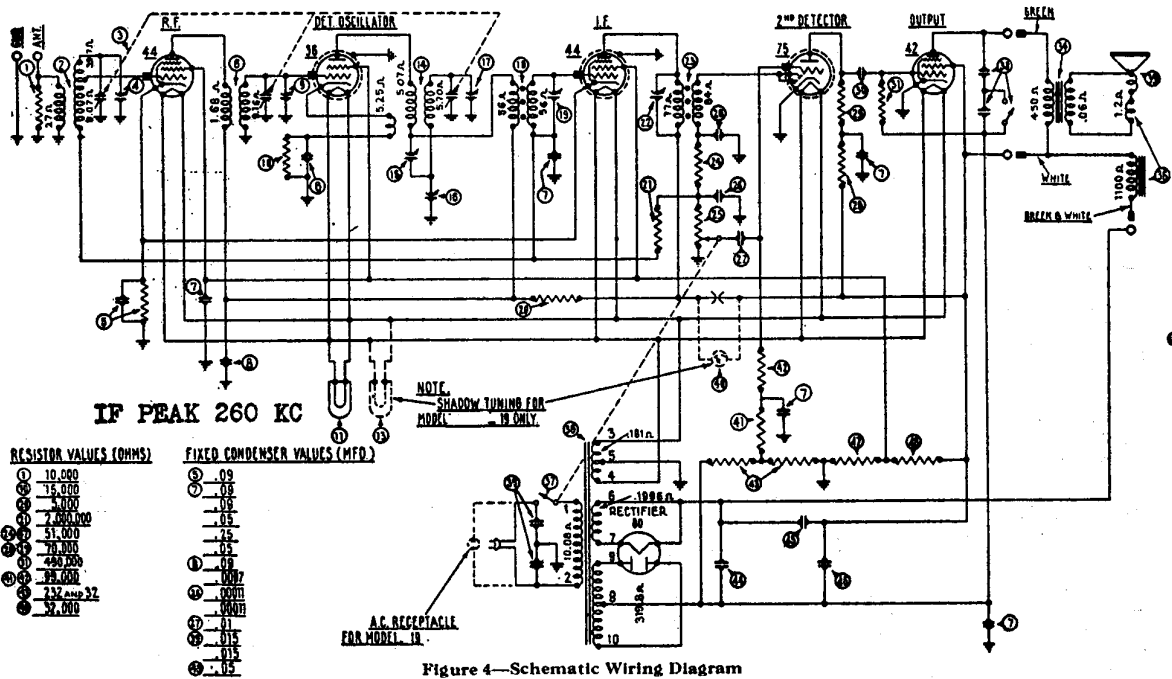
Figure 4—Schematic Wiring Diagram

In run number 5; the antenna coil ⓐ part number 06619 was changed to new coil part number 32-1062. The interstage coil ⓑ part number 06662 was changed to new coil part number 32-1063. The volume control and A. C. switch ⓓ part number 33-5004 was changed to new Volume Control (only) part number 33-5007. A combined "On-Off" and frequency change switch was added, part number 42-1002. The above changes permits the police and airplane broadcast reception.

In run number 2, Model 19-121; run number 3, Model 19-122; a (2900 ohms) resistor, part number 5309 was added. This resistor was connected between ⓐ condenser, lug No. 3 to lug No. 5 on the condenser mounted between ⓑ antenna transformer and the R. F. socket.

Below run number 4 on 89-121; run number 1 on 19-121; run number 2 on 19-122, the wiring on the compensating condenser ⓐ was reversed and the fibre nut, part number 7505 was changed to part number 3151 (brass nut); part number W-775 hole cover was added.

Use ⓐ power transformer part number 8047. Change ⓑ electrolytic condenser (6 mfd.) part number 8165 to new condenser (8 mfd.) part number 7558. Change ⓓ electrolytic condenser (6 mfd.) part number 8166 to new condenser (8 mfd.) part number 7558.
