Automatic Record Changers Part Nos. 35-1231, 35-1233, 35-1239, 35-1241

The four changers covered in this bulletin are similar mechanically but differ as to electrical characteristics and type of reproducers:

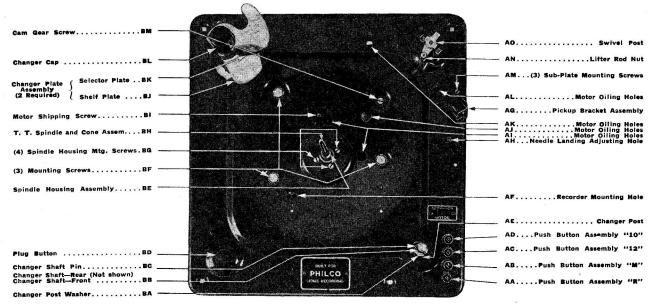
PHOTO A-B. TOP VIEW.

- Nos. 1, 2, 3: Three oil holes on motor gear housing. Reach all three through two holes AI.
- No. 4: Through hole marked AJ, drop the oil upon flat surface of cam. It will distribute itself to proper points.
- No. 5: Through hole marked AM, see felt wick, and drop the oil directly upon it.
- No. 6: Through hole marked AL, see felt wick, and drop the oil directly upon it.

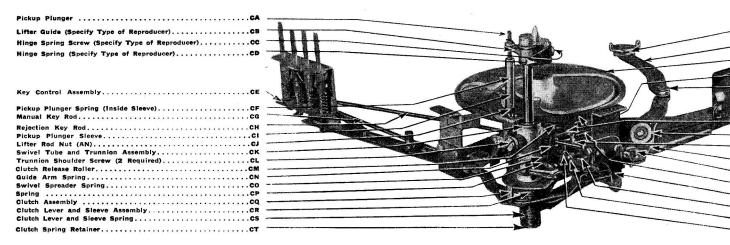
PHOTO C-D. VIEW OF SUB-PLATE ASSEMBLY, TOGETHER WITH CERTAIN OTHER

- (1) The record-changing mechanism brought into operation originally by the contact of Lifter Cam DG with Pawl DI is the simplest of the three. It is driven by the cam groove (not visible) on under side (in Photo C-D) of Cam Gear DC. As Cam Lever is forced, by the Pawl, out underneath Lift DJ (which is shown revolved to the right for visibility) the Lift rises and forces roller DE into the under groove in Cam Gear. The motion is transferred to Rear Changer Shaft (at ED) through Cam Connecting Rod EH, thence through Changer Connecting Rod FG to Front Changer Shaft at FJ.
- (2) The pickup-operating mechanism likewise brought into operation originally by the cam-and-pawl action upon Cam Lever is driven in part by the groove in upper (visible) side of Cam Gear. As Cam Lever is forced out, at the beginning of the

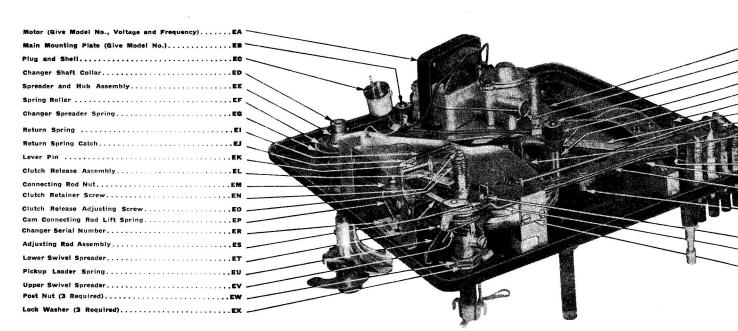
PHOTO E-F. BOTTOM VIEW.

In wiring up, use only Underwriters' Approved wire. See that Motor Frame is well grounded by wire soldered to lugs, as shown on bottom view
