# PHILCO SERVICE SUPERVISOR

JULY, 1954

## TELEVISION SERVICE "HINTS AND KINKS"

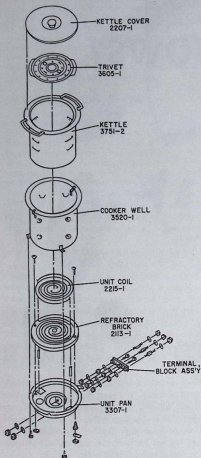
FIGURE 1

When iron is hot or wet, it seems to be most easily oxidized or rusted. If a piece of iron were heated until it was red hot, oxygen would unite with it very rapidly; that is oxidation would be speeded up, and rust would form more rapidly. As oxidation progresses, less and less pure iron remains, and finally the whole mass is reduced to an oxide.

Up until the summer of 1905 electric heaters burned out so frequently that they were practically useless. Apparently, electric heaters of iron were not practical and would never come into general use. However, as is often the case, science uncovered a new metallic alloy, and found it to be perfectly suited to the task of heating.
