Philco Model 46-1209 AM/SW Console Radio
Donald R. Sentz
July 2018, Rev. F December 2020

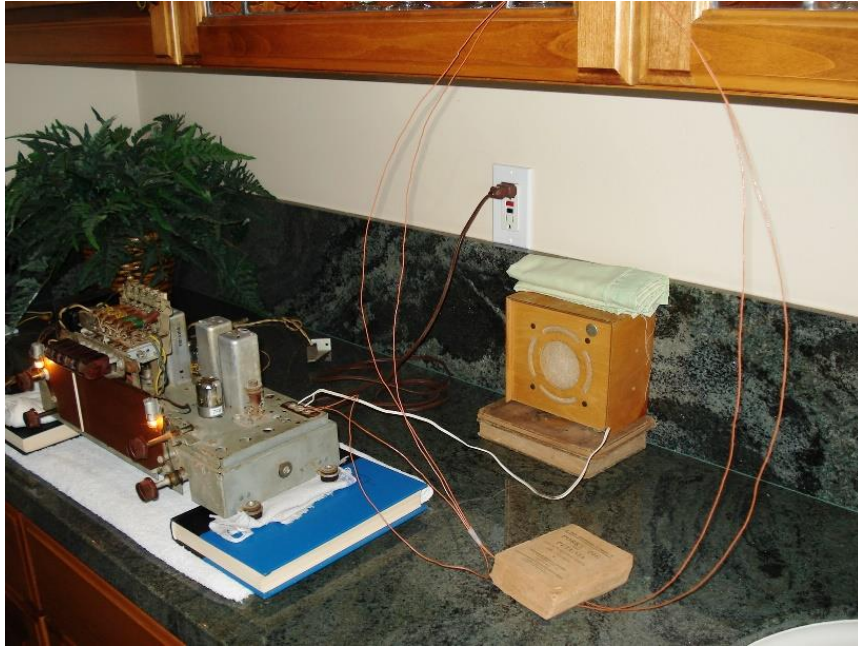
Testing Configuration Using Loop Antenna Substitute

The service sheet for this set stated 240 volts for the B+, while I measured 257 volts. I measured 120 volts on the AC line. If I step down the line from 120 volts to 112 volts, then the B+ should reduce to 240 volts, as stated in the service sheet. I made an autotransformer that will do this handily. This set was probably designed for nominal AC line between 110 and 115 volts.

While testing the phono motor circuit I measured 4.5Ω for the power transformer primary, consistent with the schematic.

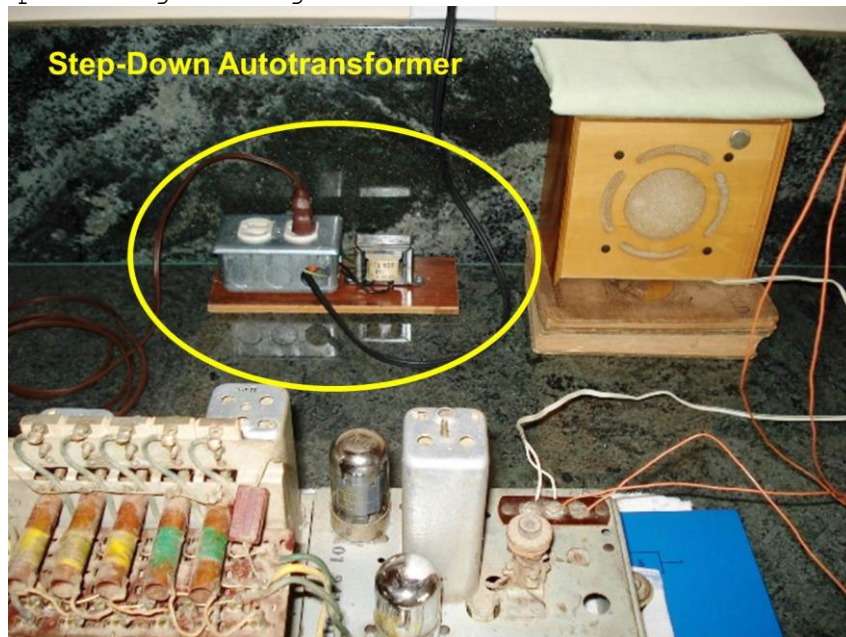
B+ = 245.7 VDC @ 94 mA

Total AC Power estimate reduces to 55 watts (plus power transformer loss) w/ autoxfmr. The power transformer gets pretty hot after a while (5 watts or so?), but this is probably normal since all operating voltages and currents look OK.

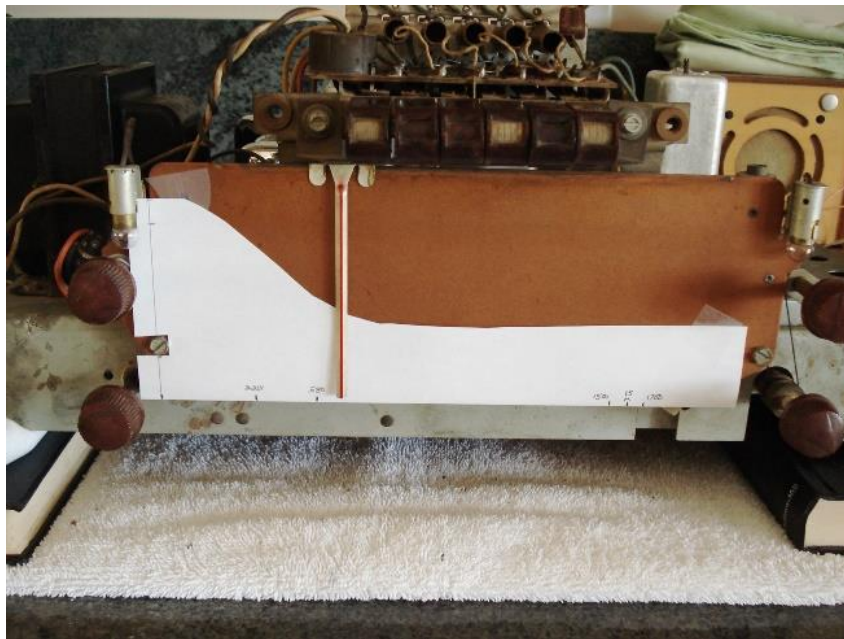
Using Dial Calibration Template

DONE August 12, 2018- I checked each frequency by using my Grundig portable set (has digital frequency display) to set the Heathkit signal generator. The dial calibration was great, even the 15MHz mark was right on, which I also confirmed by receiving WWV 15 MHz signal at that dial setting. However, when installed the pointer is slightly high relative to the AM band dial markings over lower $\frac{3}{4}$ of the band. SW band pointer reads high over lower $\frac{3}{4}$, and slightly low at top end (15MHz).
