## Philco Radio & Television Corp.

**Model:** 89

## Correcting Intermittent Operation

MODEL 89,19  
Schematic  
Alignment  
Changes

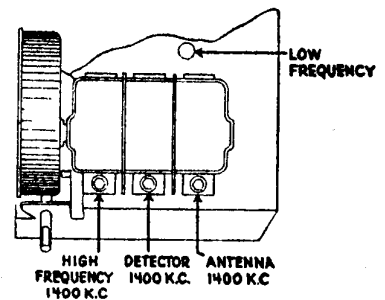
Figure 4—Top View of Chassis showing Tuning Capacitors, Models 89 and 19, also additional Compensating Capacitors

4. **COMPENSATING CONDENSERS:** The first I. F. compensating condensers in Models 89 and 19  $\textcircled{C}$  in service bulletin 146,  $\textcircled{C}$  in service bulletin 146-A and  $\textcircled{C}$  in service bulletin 166 have been changed from Part No. 04000-M to Part No. 31-6016. The new condenser has a larger insulating surface between the plates of the condenser and the mounting holes. The possibility of moisture absorption is thus eliminated. It is necessary to re-drill a hole in the chassis so that the condenser can be mounted correctly with respect to the opening in the chassis for the compensating condenser wrench.

5. **BAKELITE WASHERS:** In order to prevent moisture absorption with resulting drifting in the compensating condenser adjustment, a bakelite washer and a metal washer are now being used on top of the compensating condenser, in place of the fibre washers previously used. The part number of the bakelite washer is 27-4109 and the metal washer (placed on top of the bakelite) is W-1331. These two replace the old fibre washer Part No. 3500.
