# PHILCO SERVICEMAN

RADIO · MANUFACTURERS · SERVICE · NEWS

APRIL, 1936

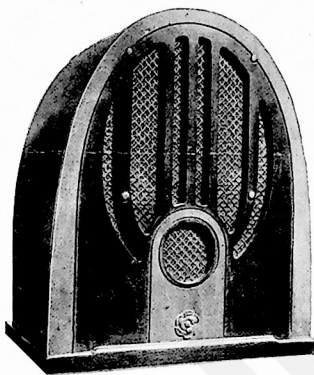
THE demand on the part of thousands of PHILCO dealers and servicemen for a standard PHILCO extension speaker has been met by PHILCO in making available the new permanent-magnet dynamic speaker housed in an attractive baby-grand type cabinet. This speaker is the standard K size and is the same speaker as that employed in the PHILCO Model 38 battery receiver. The output transformer of the extension speaker has an impedance of 20,000 ohms, which is suitable for use in connection with the average radio receiver.

Philco Extension Speaker  
Part No. 45-1224

In order to standardize and to keep the basic price down as much as possible, there is no cable, switch or volume control supplied, since these items will vary with practically every installation. In case a switch or volume control is desired, however, the small plaque on the front of the cabinet can be removed and the desired control easily installed.
