# PHILCO SERVICEMAN

RADIO · MANUFACTURERS · SERVICE · NEWS

MAY, 1937

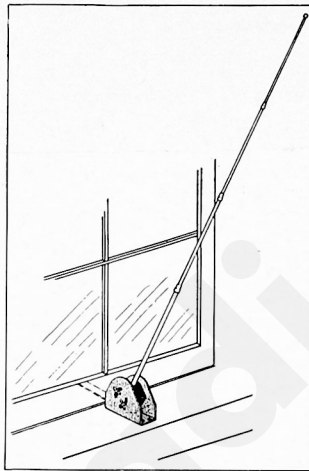
PHILCO Utility Aerial, Part 45-2450  
List Price \$5.00

The telescopic rod is stainless steel of the highest quality. It is made in four sections so that it can be any length from 18 inches out to the full, extended position. The mounting bracket is adjustable by means of thumb screws so that the angle from the building can be varied at will. A flexible, weatherproof window lead-in strip is provided with the aerial.

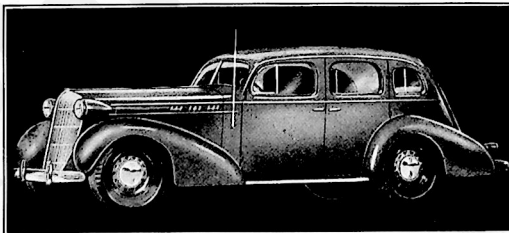
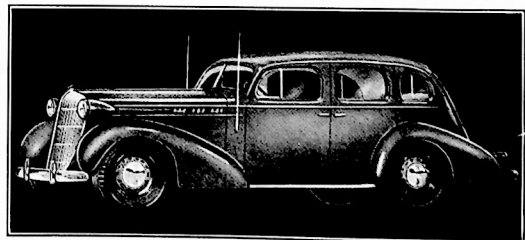
PHILCO Auto Radio Cowl Aerial, Part 45-2470

The appearance of the new cowl aerial is most attractive, the rod being one-piece, tapered, 7/32-inch solid steel, chromium plated, 54 inches long. The two insulating supports are black bakelite.

Showing two PHILCO Cowl Aerials installed. Engineering tests show that double the signal pickup may be obtained when two aerials are used. Appearance is greatly improved.
